Frequency and characteristics of sediment delivery pathways from forest harvest units to streams

S.E. Litschert^{a,*}, L.H. MacDonald^b

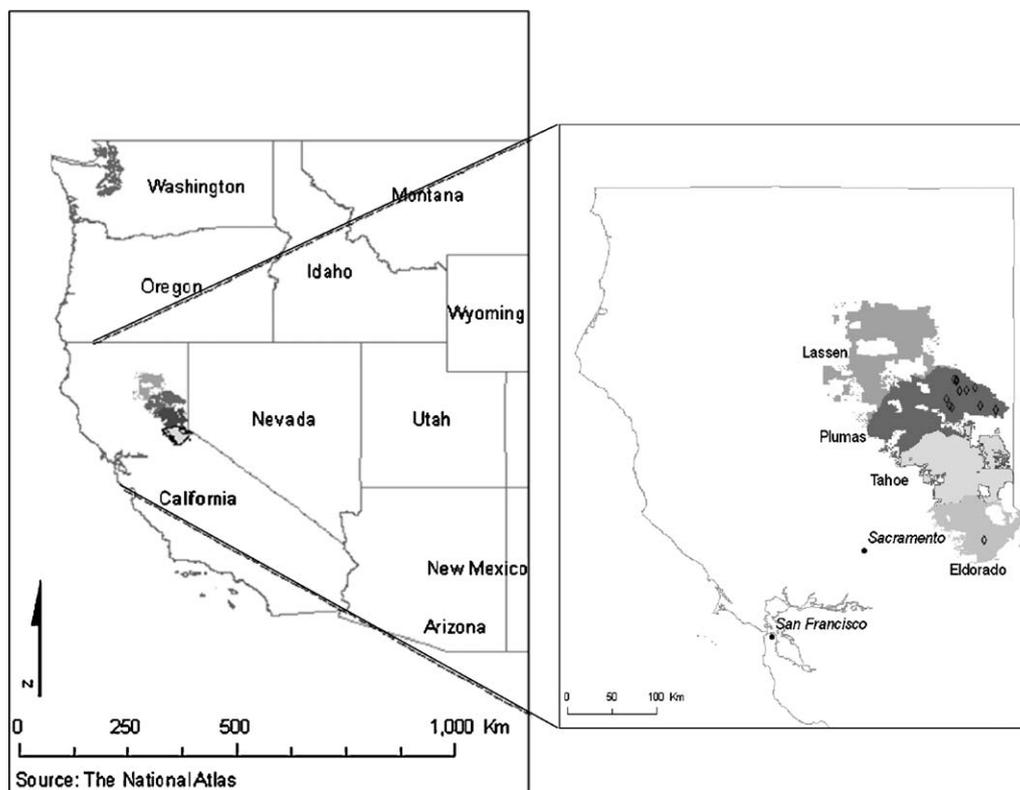
Fig. 1. Location of the four National Forests used to assess harvest unit connectivity. The open diamonds indicate the location of the rills and sediment plumes identified in this study. Given the coarse scale of this map, some diamonds represent multiple features that occurred in close proximity.

The study area included timber harvest units on the Eldorado, Lassen, Plumas, and Tahoe National Forests (NF) in the Sierra Nevada and Cascade mountains of California (Fig. 1). The area has a Mediterranean climate with moist air flows from the Pacific Ocean. The amount and type of precipitation is heavily influenced by the high elevations and rain shadow effect of the mountains so that mean annual precipitation ranges from as much as 2000 mm on the west side to as little as 370 mm on the east side (Teale GIS Solutions Group, 1997). Ninety-five percent of the precipitation occurs during the winter wet season, and above 1500 m the

The study was conducted on the four NFs shown in Fig. 1 because they have higher levels of timber harvest than the other eighteen NFs in Region 5 of the USDA Forest Service (USFS). Most of the recent timber management projects in these NFs tend to be larger-scale projects of about five hundred to several thousand hectares. Individual harvest units within these project areas average 15 ha with a general range of 1–80 ha (Tangenberg, USFS, pers. comm., 2008).

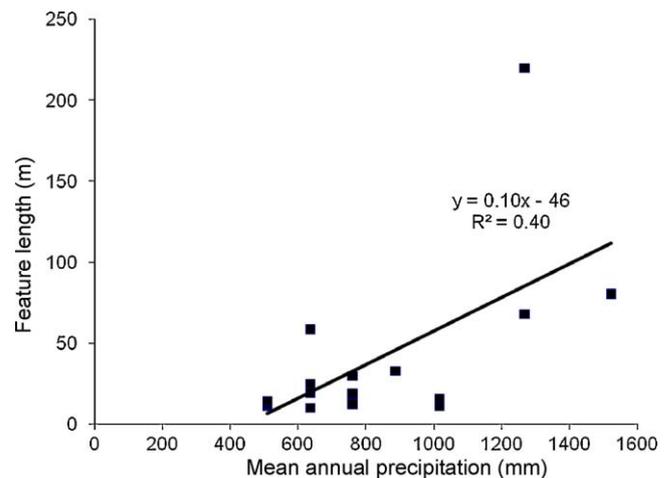
Fig. 2. Length of each rill and sediment plume plotted against mean annual precipitation.

Log-transformed feature length increased significantly with MAP ($R^2 = 0.45, p = 0.002$; Fig. 2) and years since harvest ($R^2 = 0.34, p = 0.009$). The two longest features drove both of these relationships, as they were in an area with high MAP and on 18-year old clearcut units (Fig. 3). If these features are excluded, neither MAP nor years since harvest were significantly related to feature length.

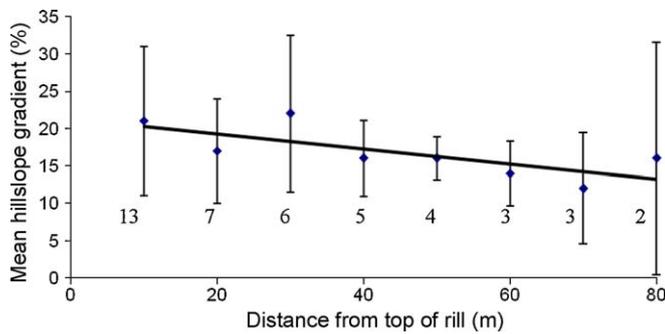
Fig. 4. Average hillslope gradients decreased with increasing distance from the top of the rills ($R^2 = 0.54$, $p = 0.04$). The bars show one standard deviation and the values below each bar represent the number of rills.

Hillslope gradients tended to decrease with distance from the top of the rills ($R^2 = 54\%$; $p = 0.03$; Fig. 4). Rill width and rill depth did not show a strong, consistent relationship with the absolute or relative distance from the top of each rill. In some rills rocks, roots, or trees affected the size and shape of the rill, and the resulting abrupt changes in gradient and channel dimensions helped explain the lack of any consistent relationships between rill dimensions and the distance from the top of each rill.

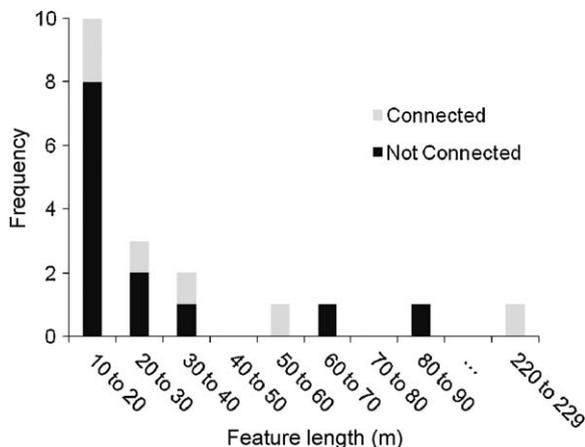
Fig. 5. Frequency and connectivity of features by length class.
